O & M INSPECTION REPORT FOR NAVIGATION PROJECTS  
Honolulu Engineer District  
CEPOH-EC-T

1. Project Name: Kawaihae Small Boat Harbor

2. Date of Inspection: June 29, 2007

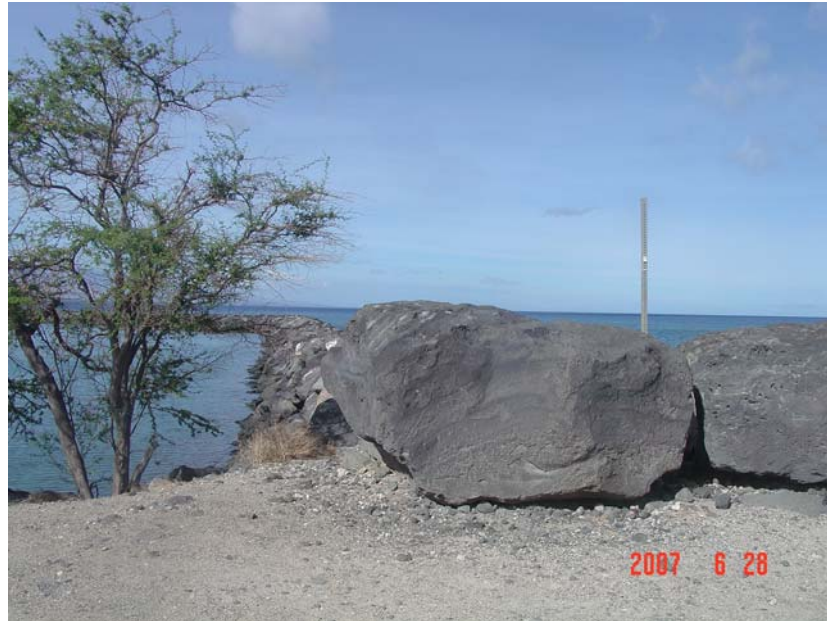
a. Breakwater warning sign missing.

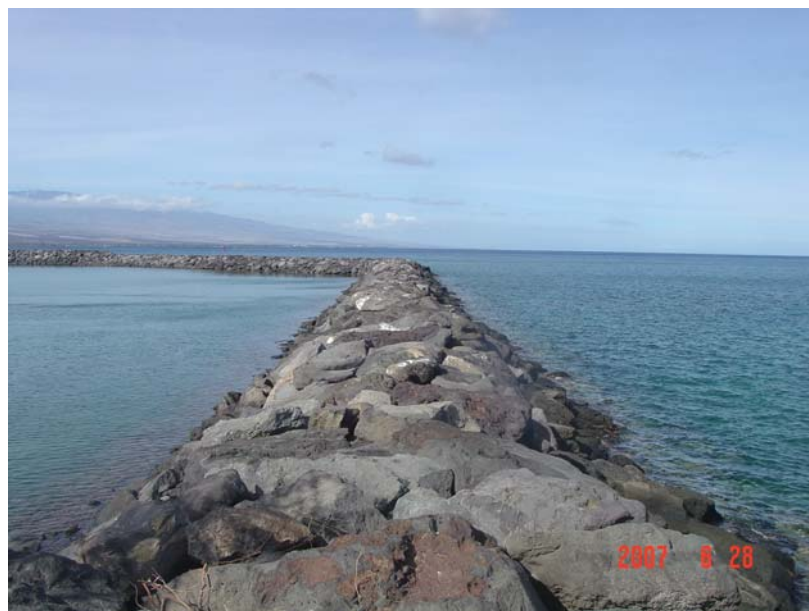
b. Sta. 0+00, Overview photo for reference.

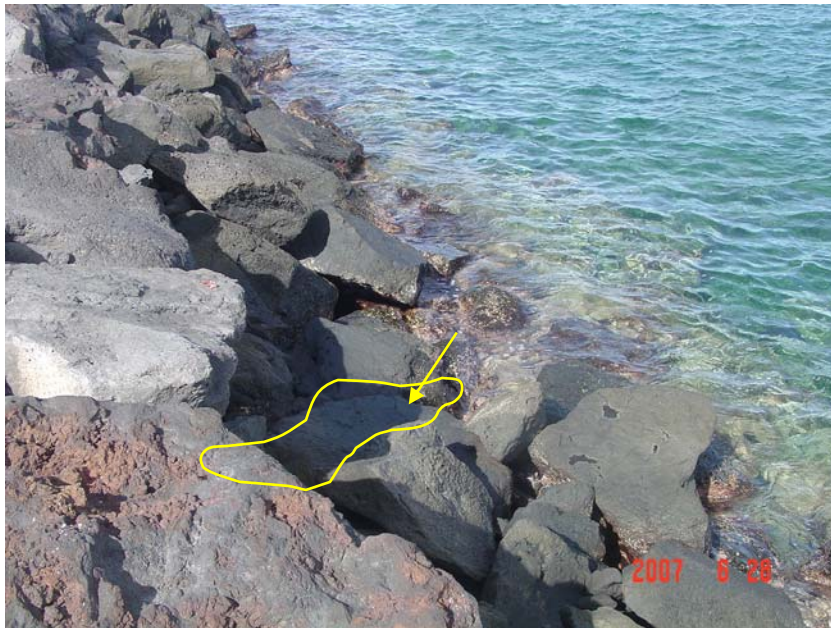
c. Sta. 2+50, OS, Dislodged armor stones on sideslope.

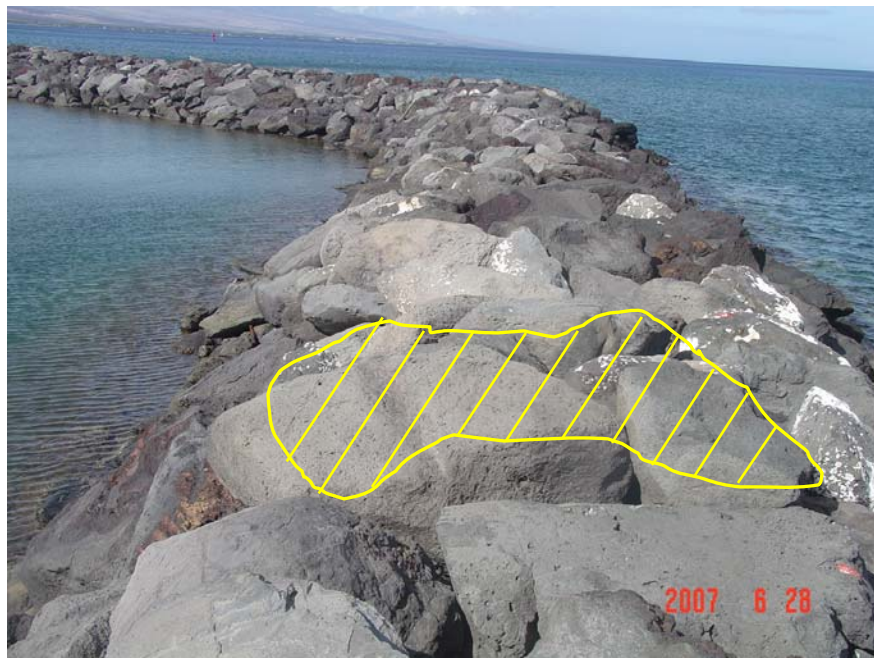
d. Sta. 2+80, OS & HS - Crest, Settling of armor stones approx. 4' deep. Monitor this area.

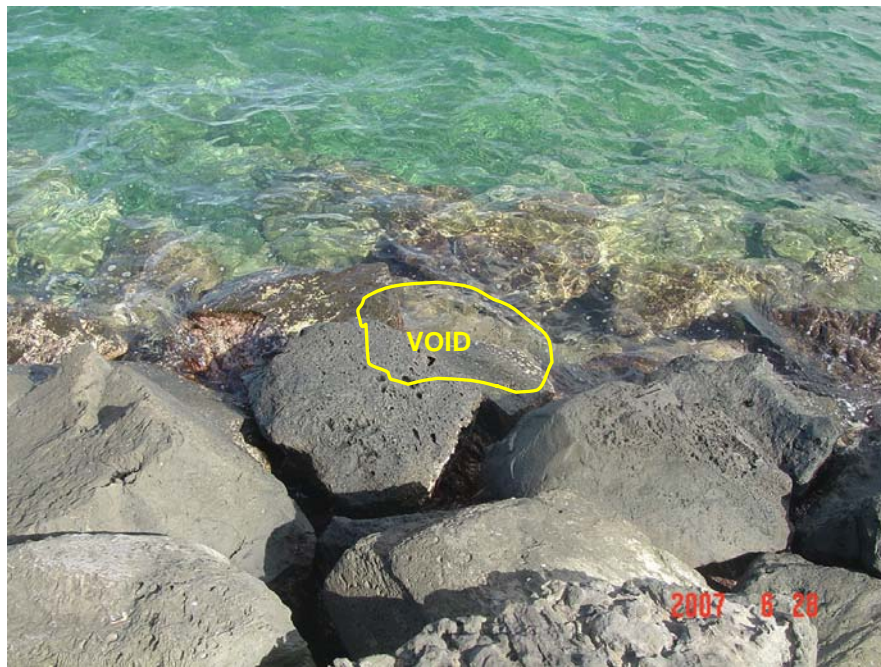
- e. Sta. 3+00, OS, Displaced armor stone & exposed underlayer at waterline.

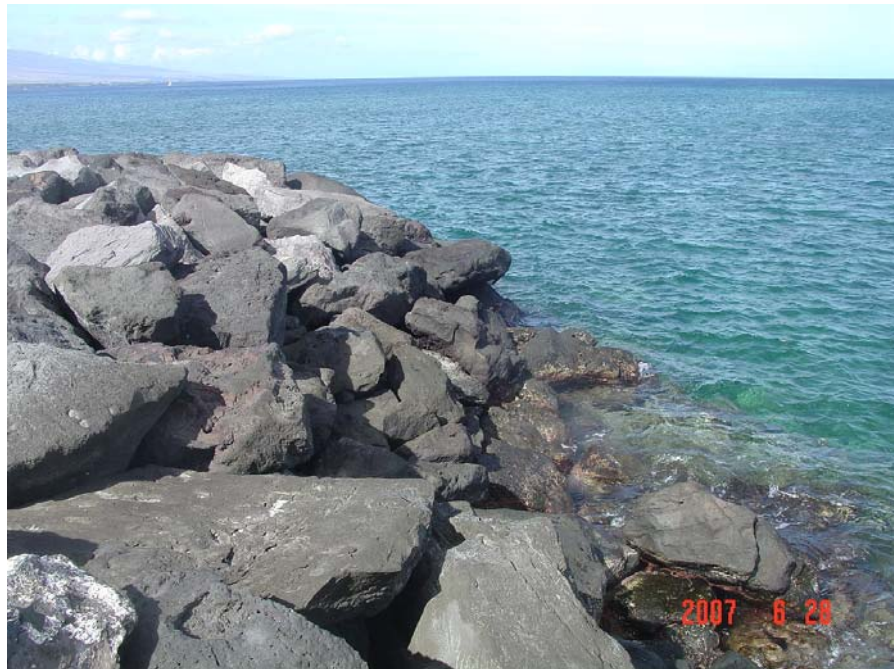
← ARMOR STONE  
DISPLACEMENT

f. Sta. 3+45, OS, Settling at crest, armor stone displacement at

toe.

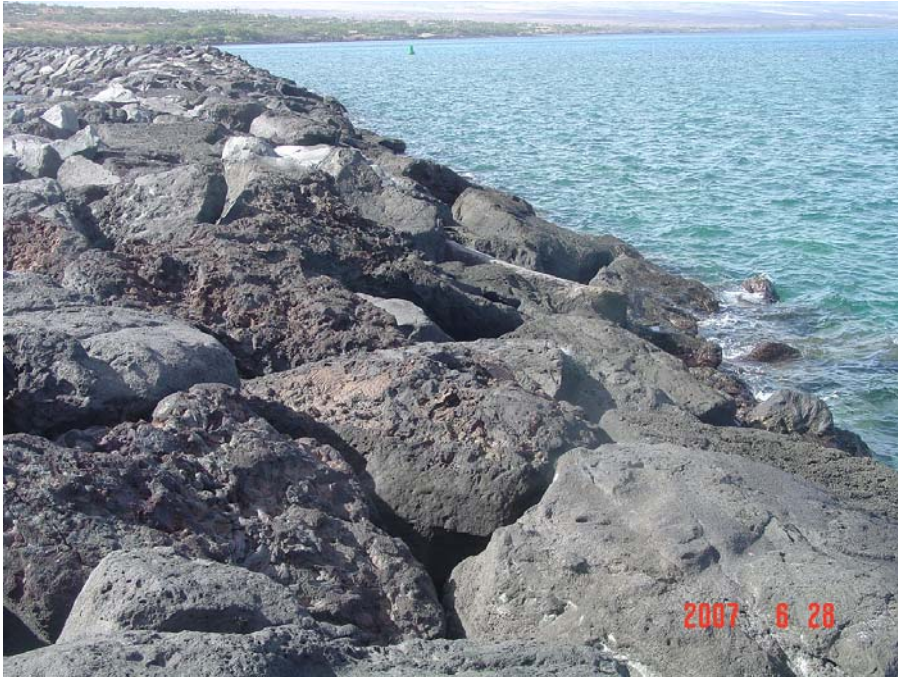
g. Sta. 5+00, Crest, cracked armor stone.

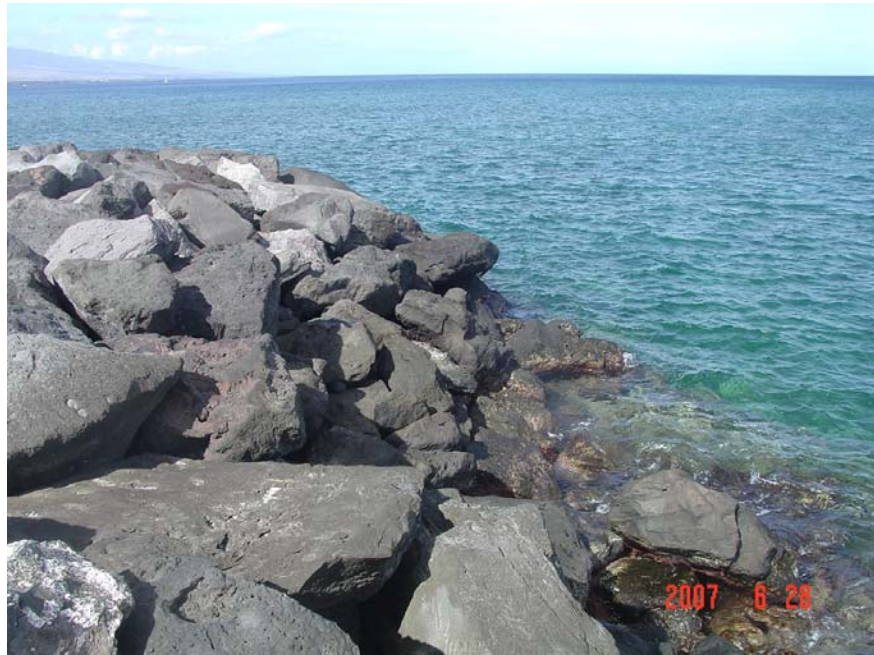
h. Sta. 5+30, OS, Photo for reference, sideslope very steep, dislodged armor stones.

NOTE: Construction QA Report: Sta. 5+43, 6+50, 8+60 to 8+83, underwater inspection report states "...vertical placement, slide potential".

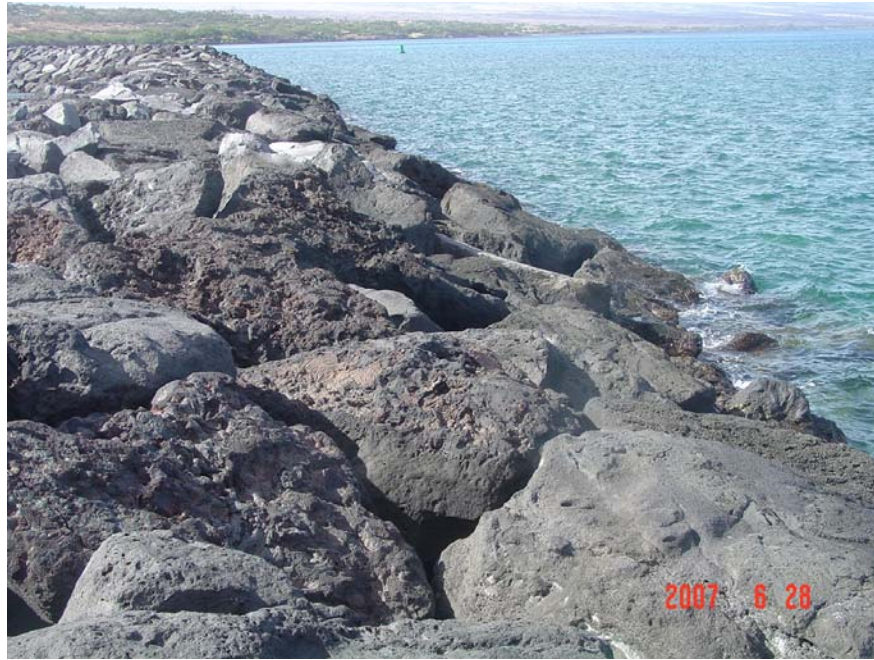
i. Sta. 5+35, OS, Possible sideslope sliding, dislocated armor stones, and void approximately 15 linear feet.

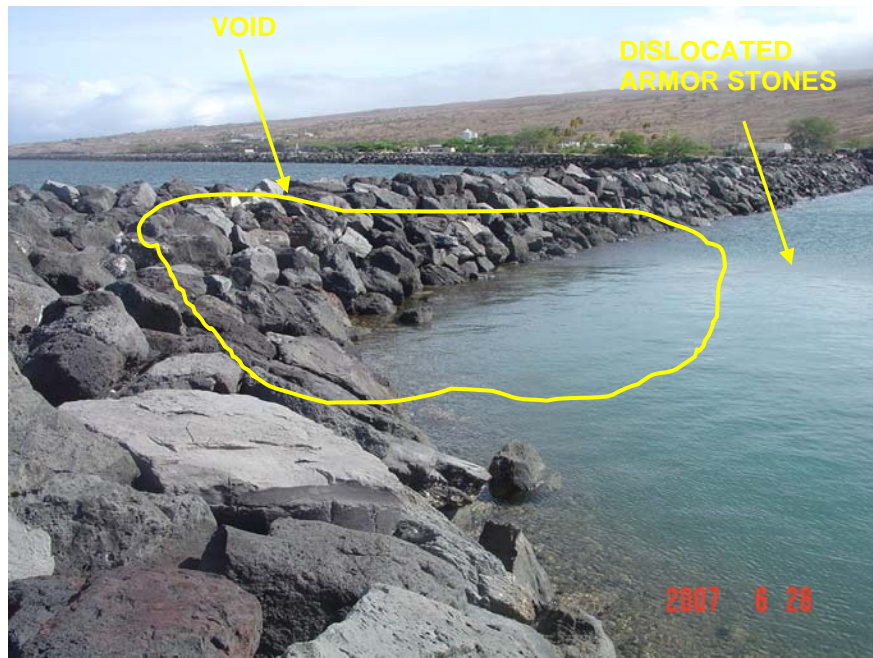
j. Sta. 5+45, HS, Minor sideslope settling, 2 ea. Dislodged armor stones.

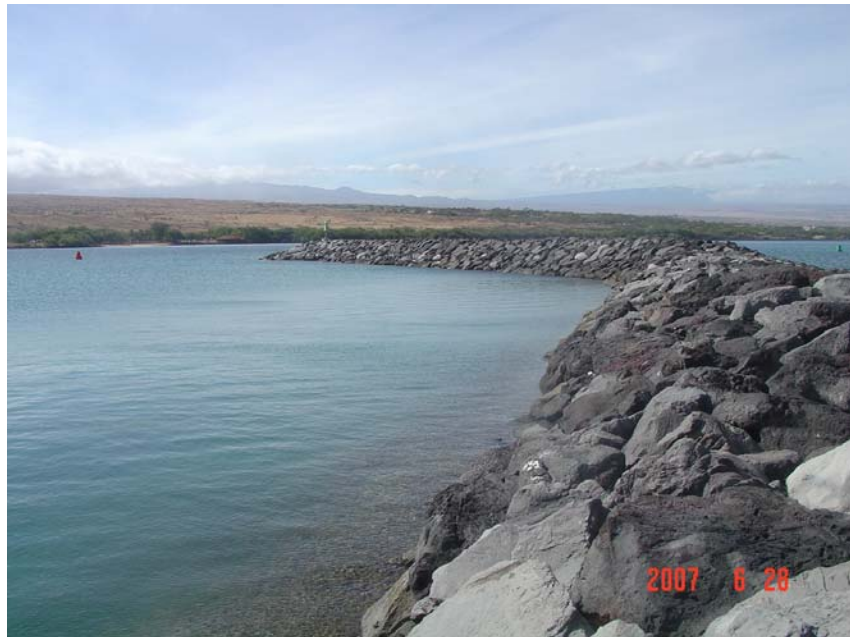
k. Sta. 5+40, Overview photo for reference.

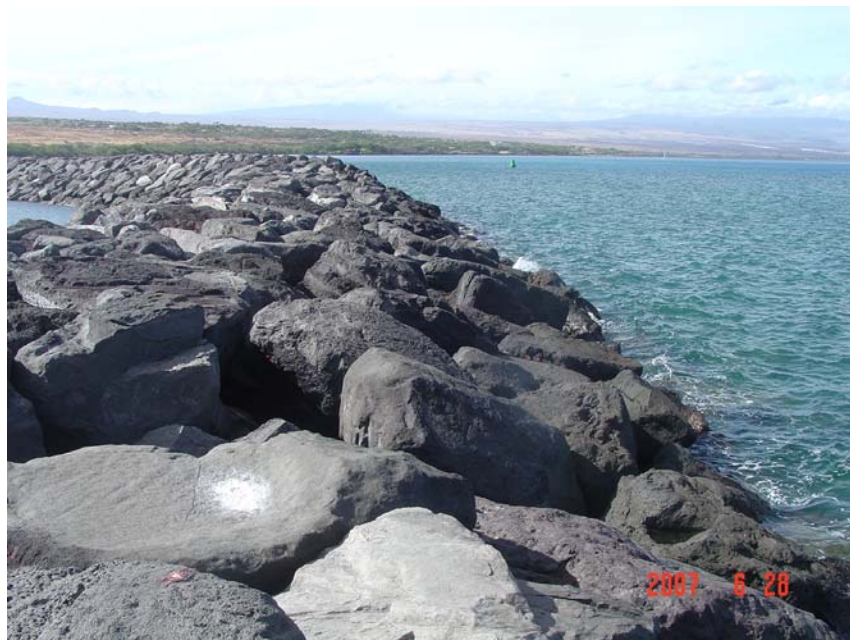
l. Sta. 5+50 - Sta. 5+75, OS, Possible sideslope failure, toe stones missing, void, approx. 20LF.

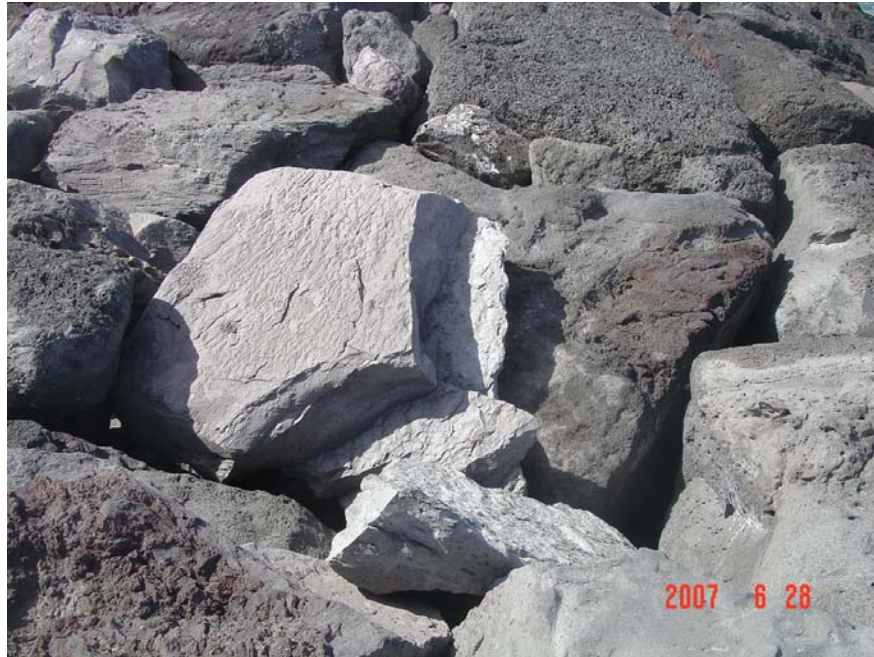
m. Sta. 5+75, Cracked armor stone at centerline of crest.

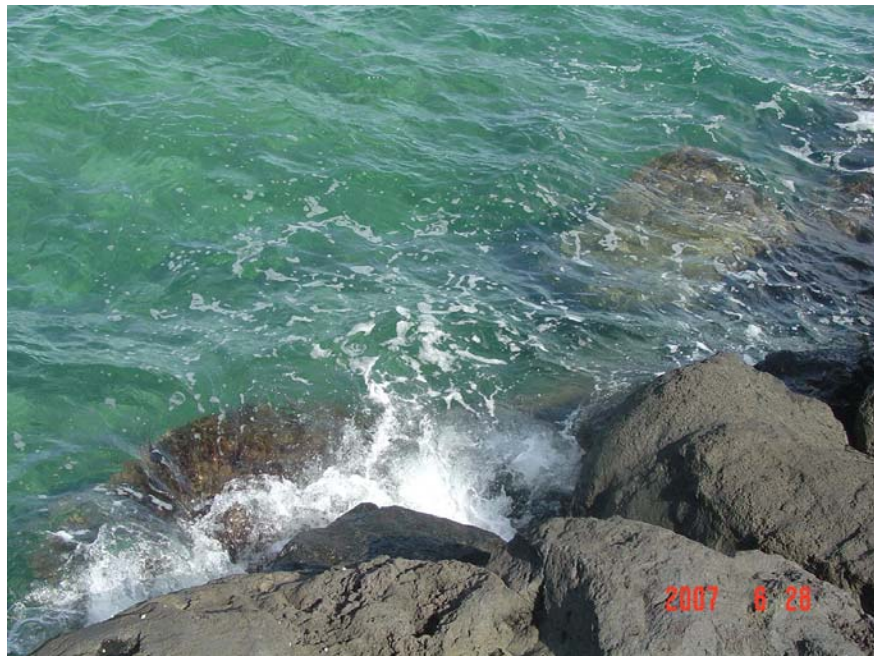
n. Sta. 6+00, OS, Dislodged armor stone @ toe, cavity/void.

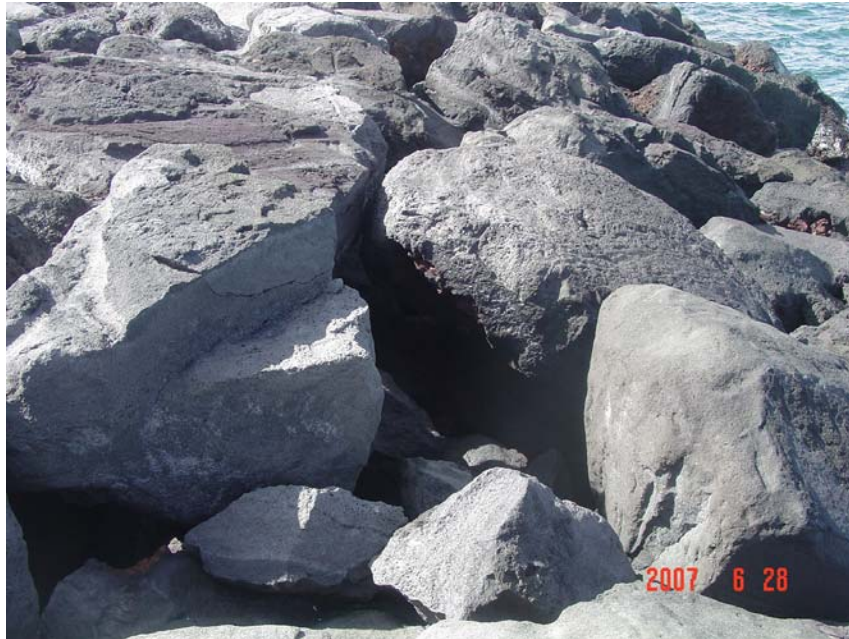
o. Sta. 6+50, OS, Cavity, five foot dia., sideslope steeping.

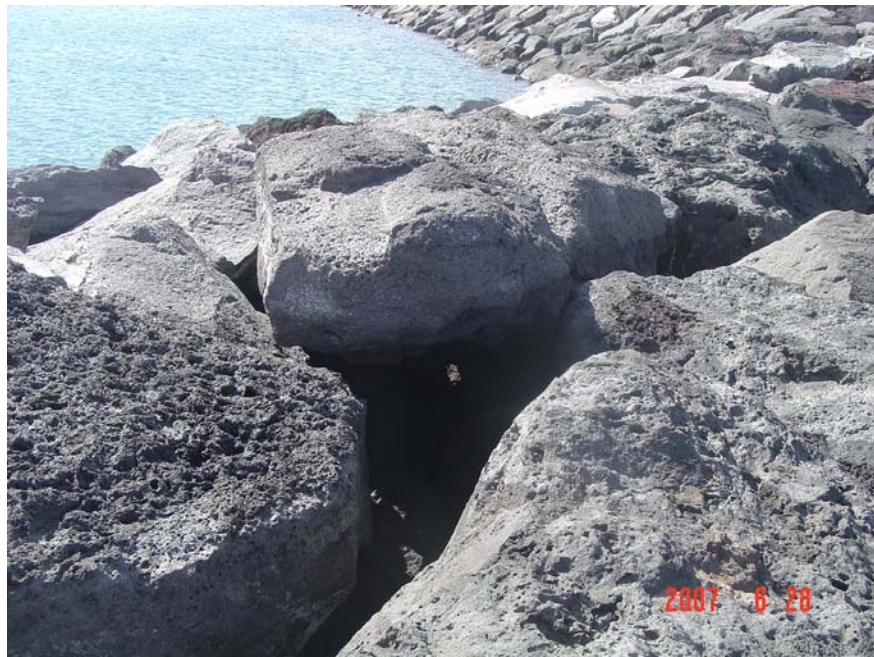
p. Sta. 7+10, OS, Bridging of armor stone, large cavity.

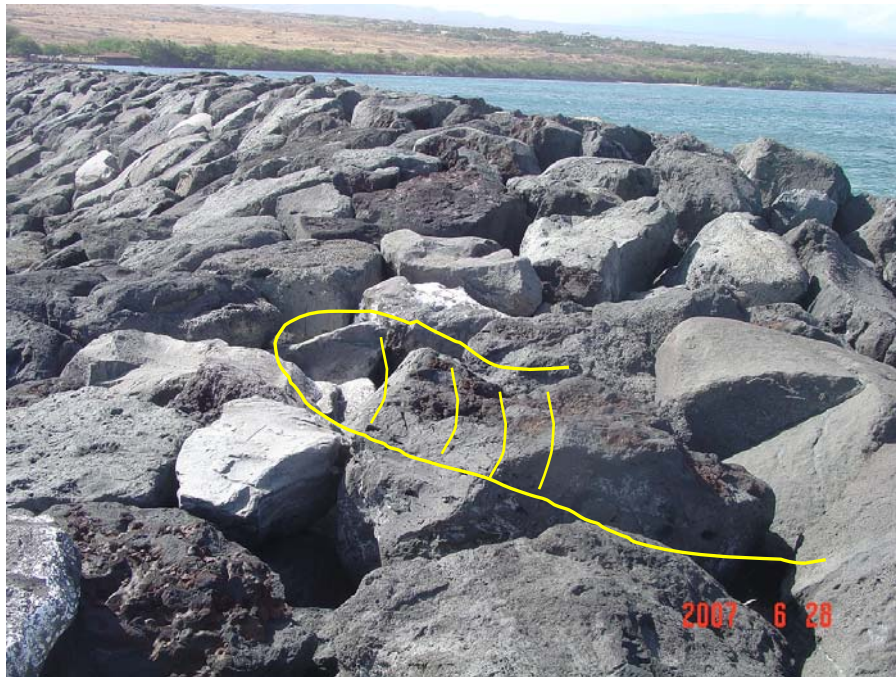
v. Sta. 9+00, HS, Flattening of the sideslope.

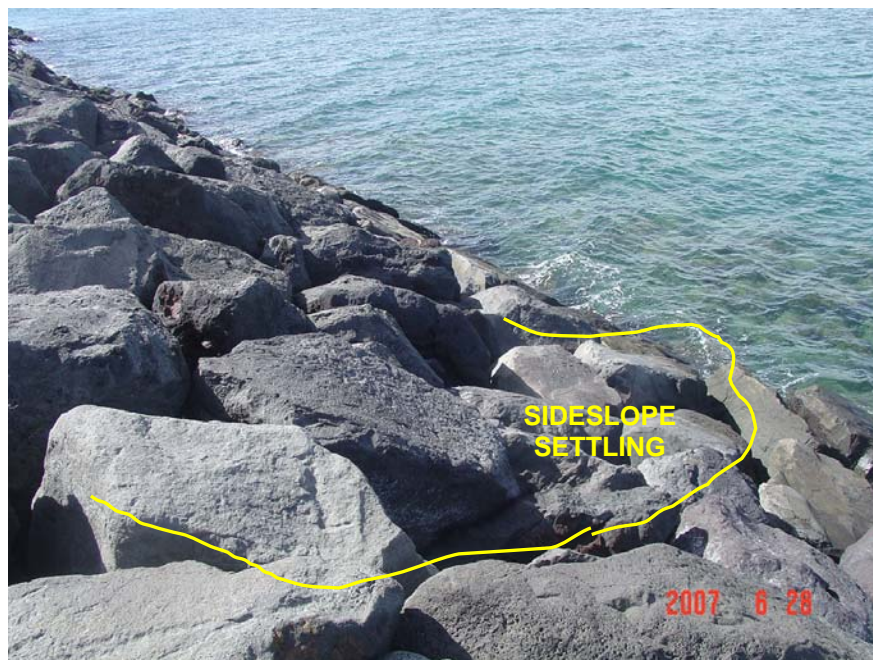
w. Sta. 9+00, OS, Settling of sideslope.

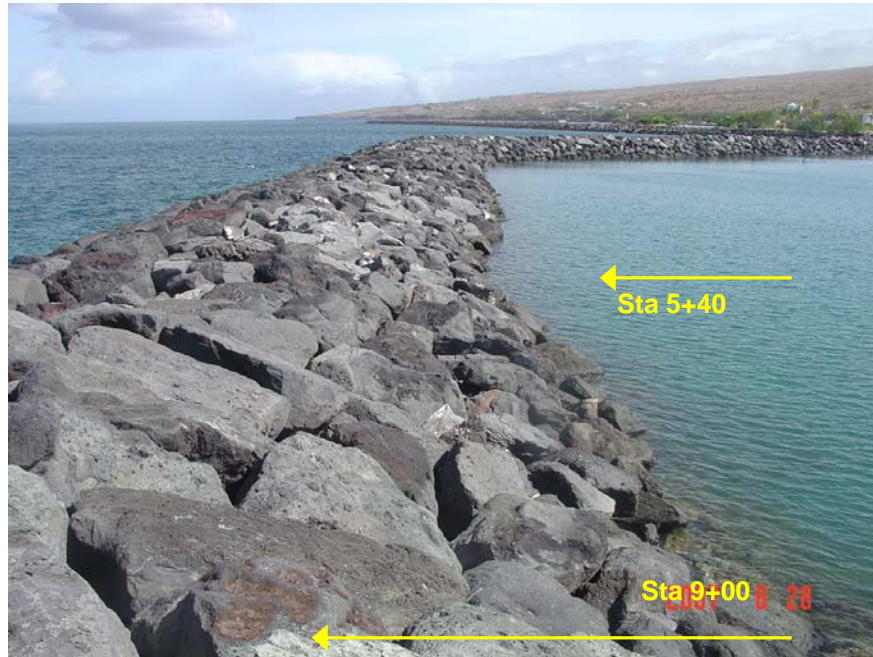
x. Sta. 9+00, HS, Overview of mid-section settling.

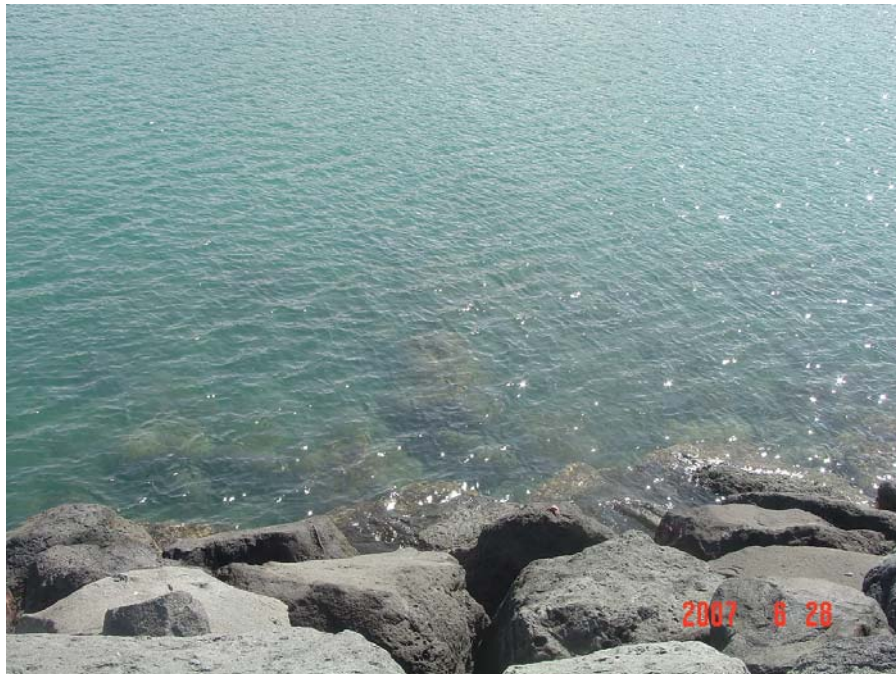
y. Sta. 9+45, HS, Several dislocated armor stones.

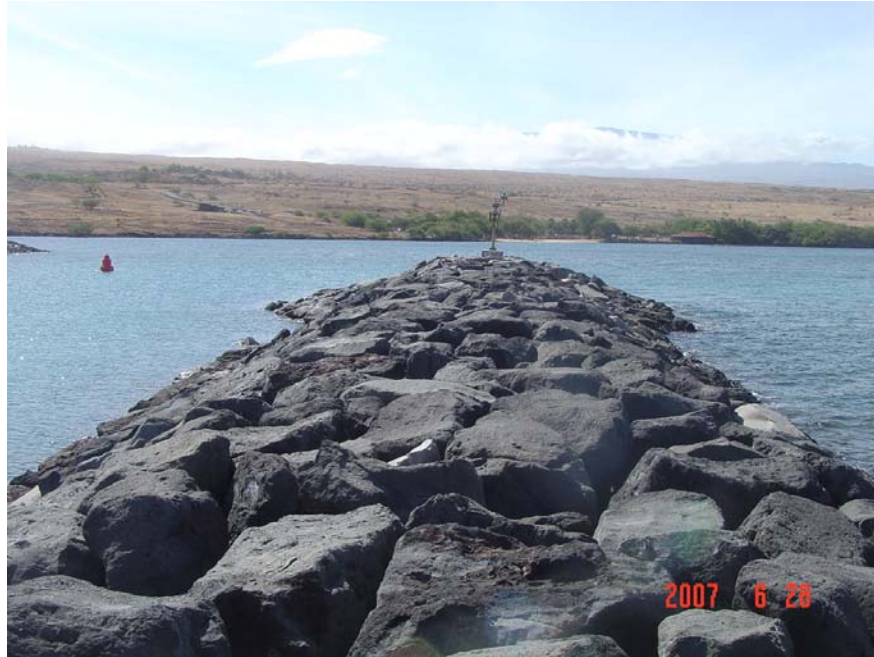
- z. Sta. 9+75, OS, Overview photo for reference.
- aa. Sta. 10+00, OS, Bridging, armor stone @ toe w/o contact.  
(2003 Photo)
- bb. Sta. 11+00, Crest, Cracked armor stone.
- cc. Sta. 11+00, HS, Chinker 2/3 up the sideslope, no bottom contact.
- dd. Sta. 11+20, HS, 3ea. chinkers, one 12T-15T armor stone bridging.
- ee. Sta. 11+50, OS, 2ea. armor stones at waterline dislodged.
- ff. Sta. 12+15, OS, Armor stone larger than specified in the contract specs, 15T-18T.
- ll. Sta. 12+20, OS, 1ea. armor stone bridging.

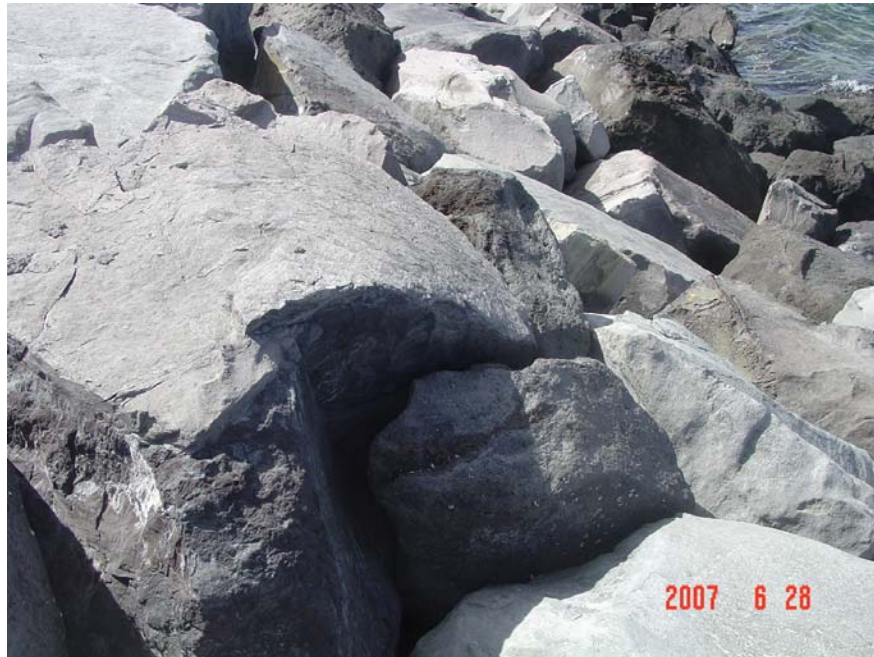
gg. Sta. 12+10, OS Hinge, Split armor stone (FY 2002 Photo).

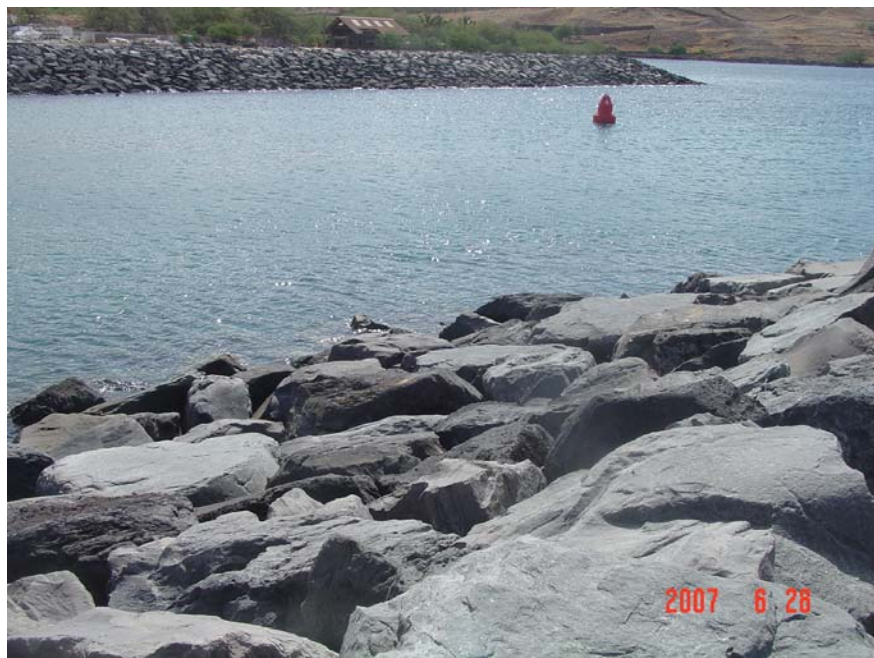
hh. Sta. 12+10, HS Head, slight sideslope settling .

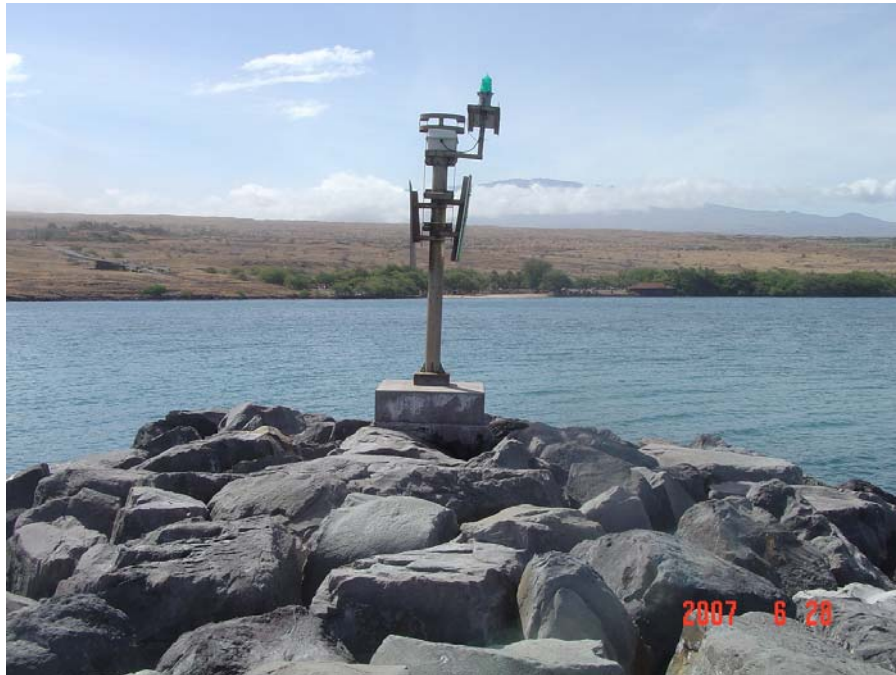
ii. Sta. 12+60, The head is settling on the Oceanside of the structure causing the NavAid to lean.

West B/W - Good, Only minor deterioration is evident, but function is not significantly affected. Areas of most concern are oceanside and crest settling. East B/W - Fair, Deterioration is clearly evident, but the structure still appears sound. Project should be inspected after all high wave actions to determine if repairs are required. USCG to be notified of NavAid condition.

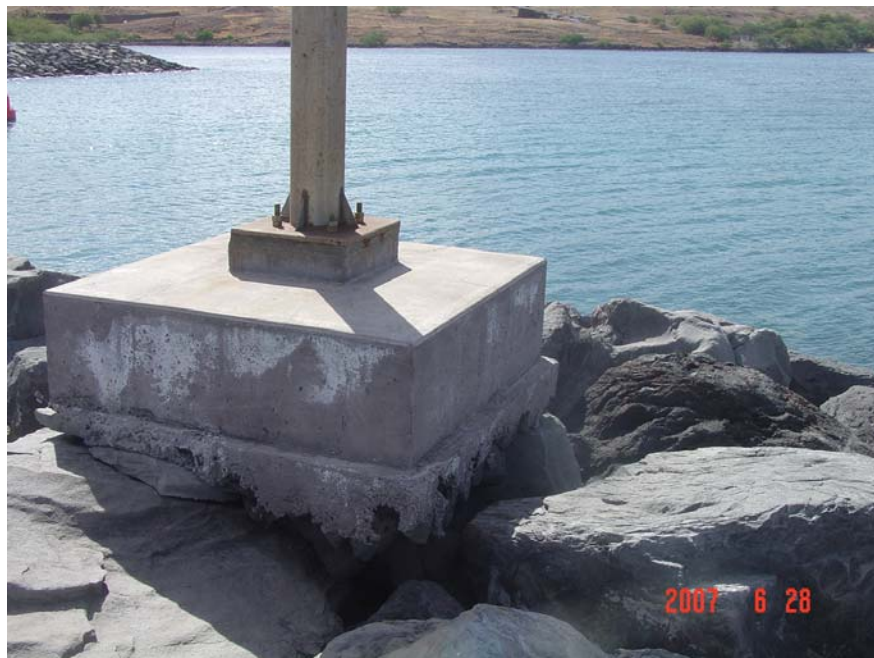
jj. Same as above.

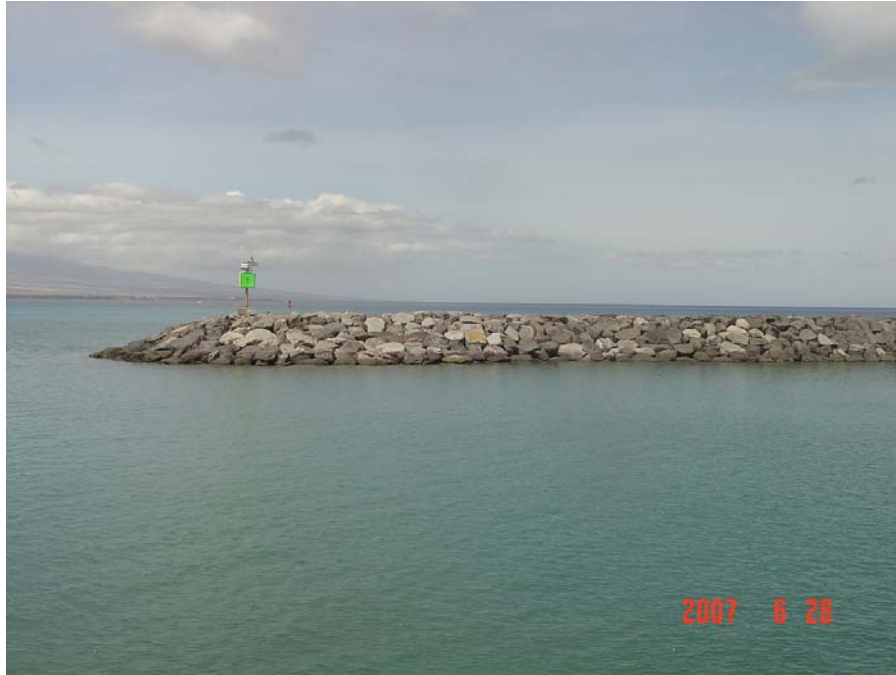
kk. Sta 12+60, Head of West BW. Some settling of armor stones at the head since previous inspection.

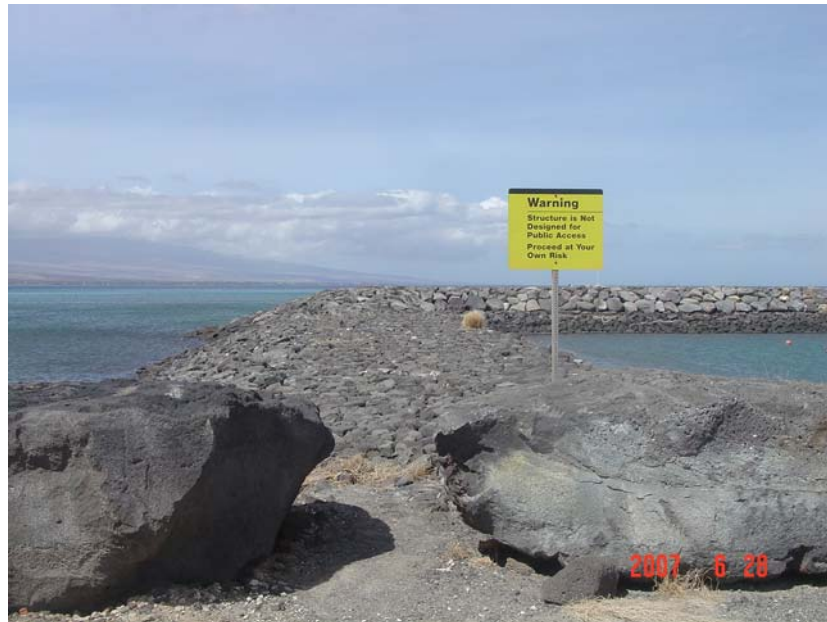
a. Sta. 0+50 to 2+00, harbor and ocean side. Numerous voids in the armor layer, which expose the underlayer. Underlayer and armor stones are undersized. Most undersized stones appear to be located within the splash zone of both the HS and OS.

b. Sta. 2+65 to 2+80 missing armor stones in bend, HS. Coral material has washed up and is filling the voids.

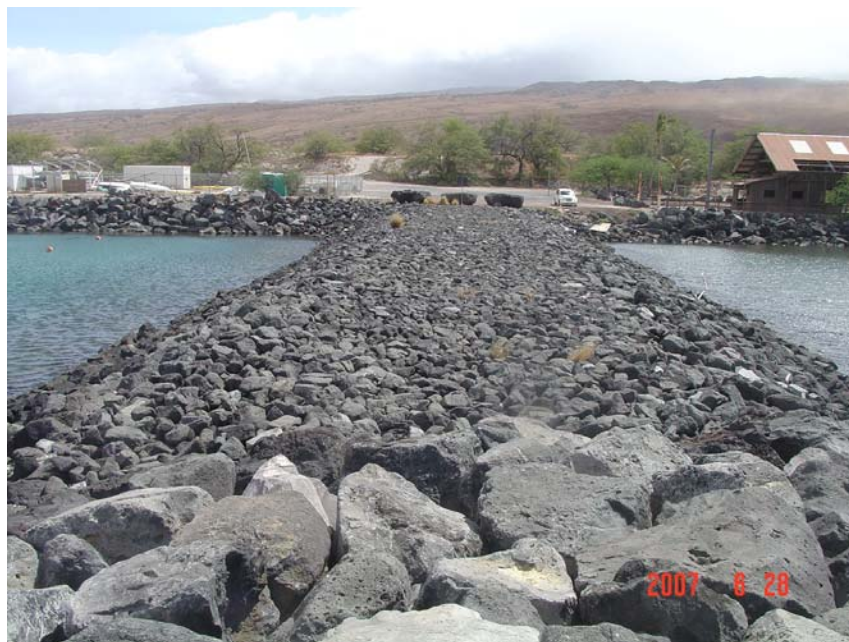
c. Sta. 2+80 to 4+00, OS, Monitor minor settling on sideslope.

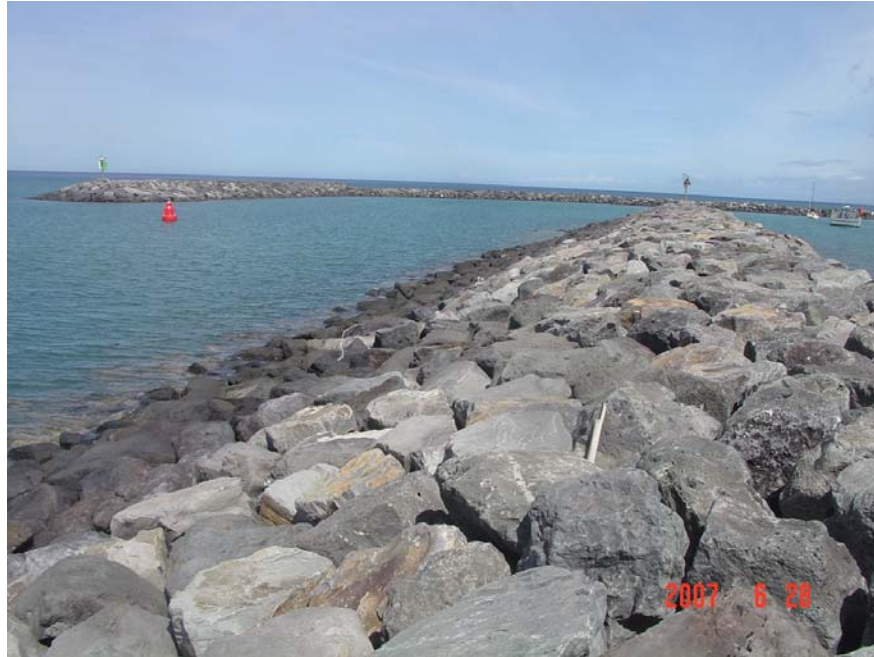
- d. Sta. 4+36 - Sta. 4+60, OS, minor sideslope settling 30'x40'.

**Note:** Sta. 3+30 to 7+10, HS. Armor stones lacks adequate contact with underlayer section. Armor stones are perched (by the use of very small stones) above the underlayer section.

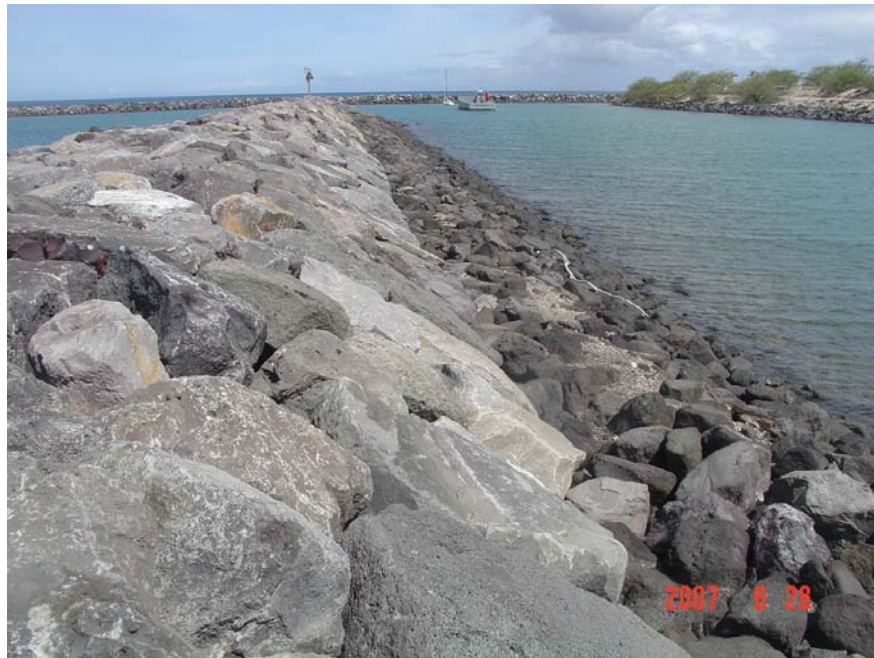
- e. Sta. 4+36, HS, Minor the sideslope has begun to creep.

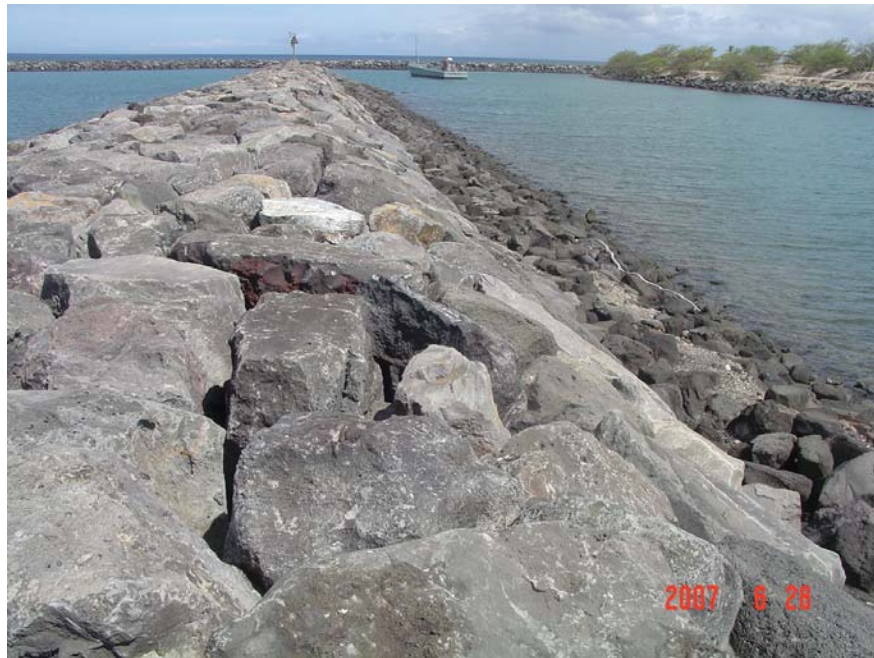
f. Sta. 4+36, HS, hinge separation.

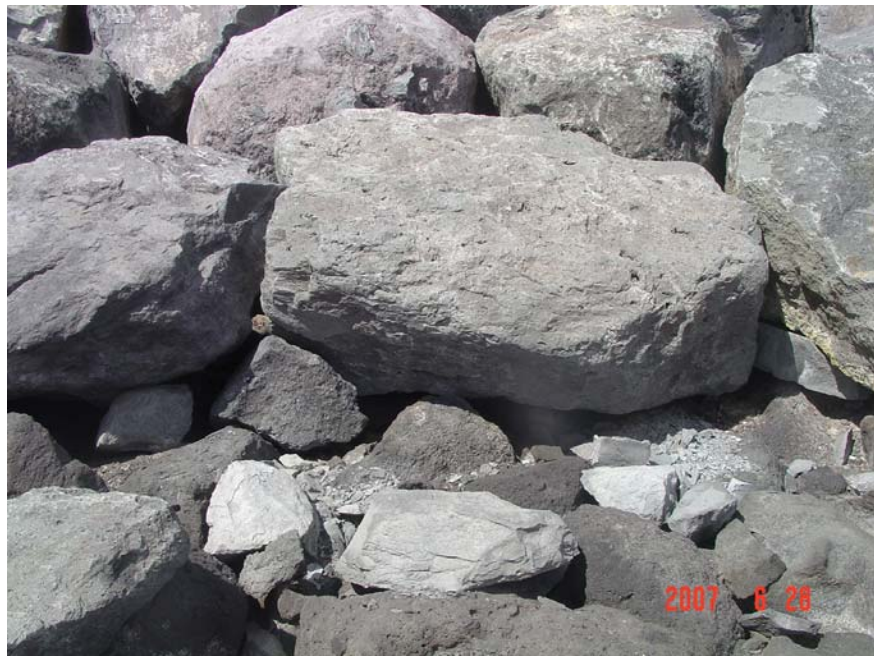
- g. Sta. 4+50, HS, Chinkers have begun to break due to weight of armor stone.

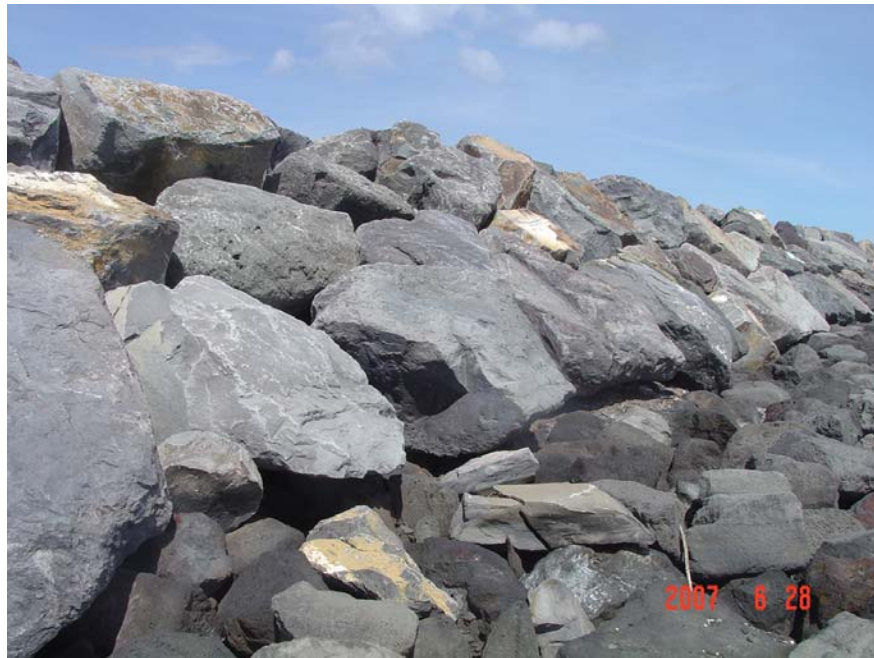
- h. Sta. 4+50, HS, Chinkers have begun to break due to weight of armor stone, sideslope beginning to separate @ the hinge and creep @ the toe.

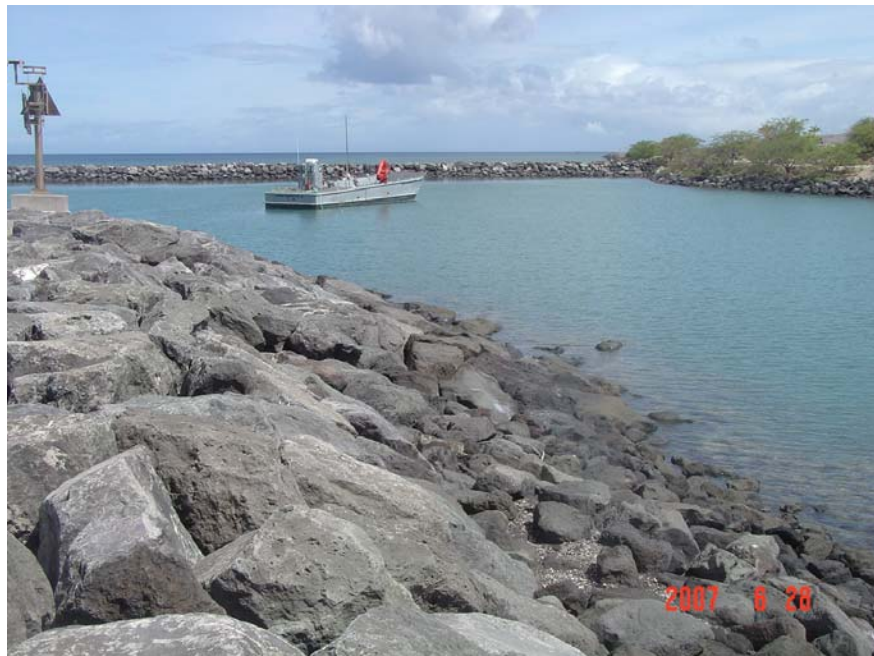
- i. Sta. 7+50, HS, 1 armor stone appears to be dislodged but has contact.

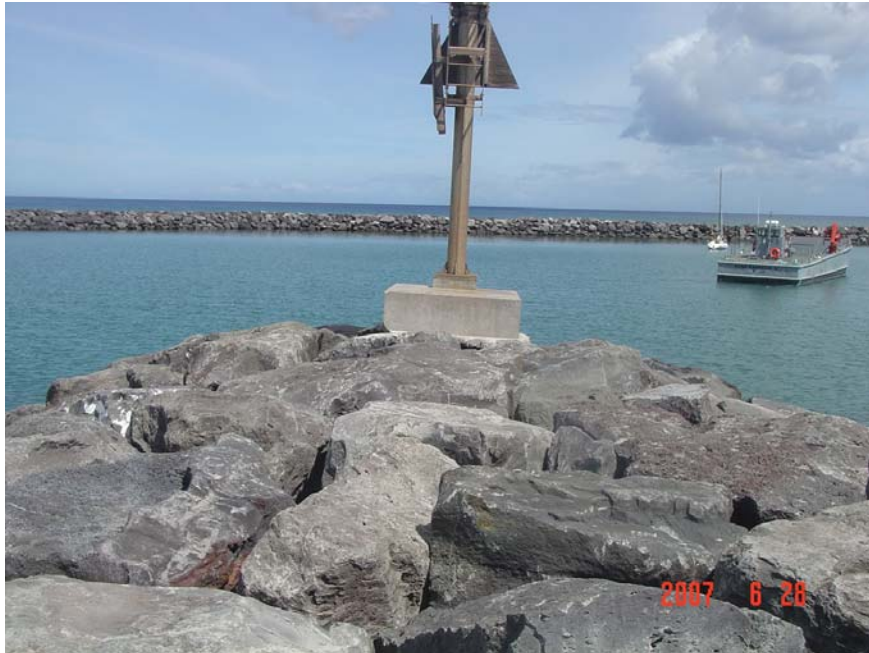
- j. Sta. 7+80, Head, HS, structure settling causing the NavAid to lean.

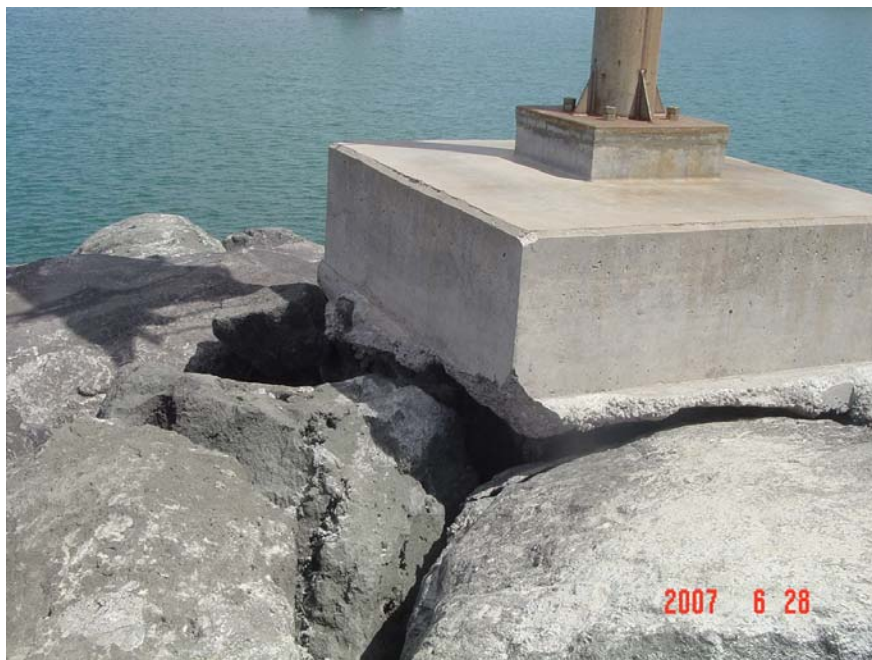
- k. Sta. 7+80, NavAid Same as above.

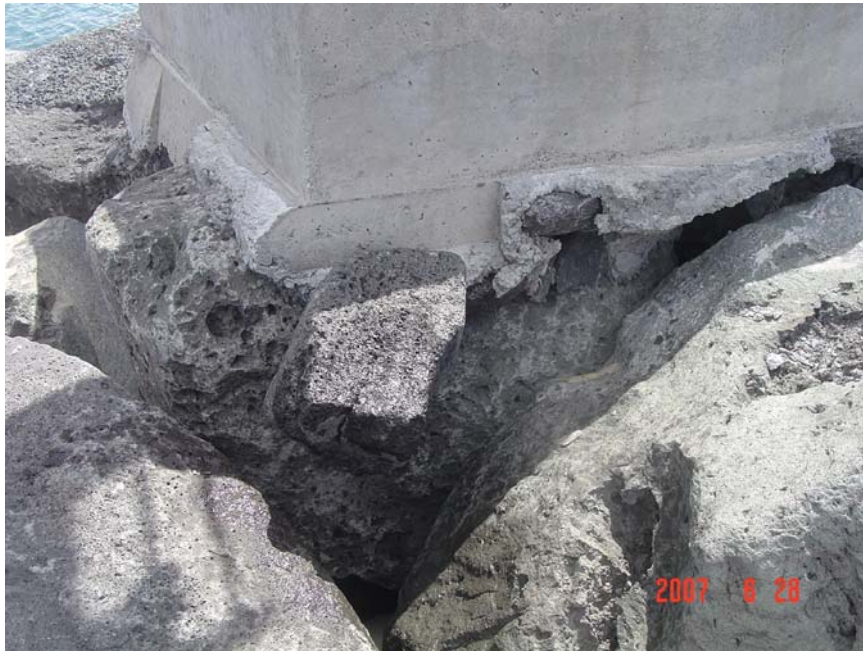
l. Sta. 7+80, NavAid Same as above.

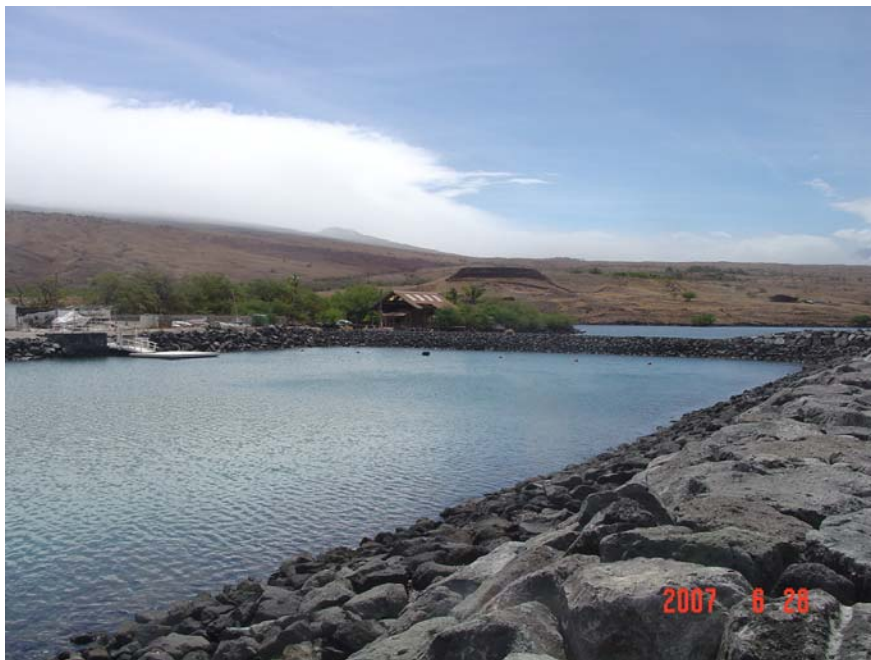
k. Sta. 7+80, Overview of interior
